**AIRWORTHINESS DIRECTIVE**

No. 2026-FATA-010144R-01

Applicability – ANSAT helicopters (ANSAT, ANSAT-GC models) and their modifications  
Designer's State - RUSSIAN FEDERATION

**TECHNICAL DECISION No. 1/144-2025-KB3**  
on continued airworthiness of the ANSAT helicopters (ANSAT, ANSAT-GC models)  
**Revision 2**

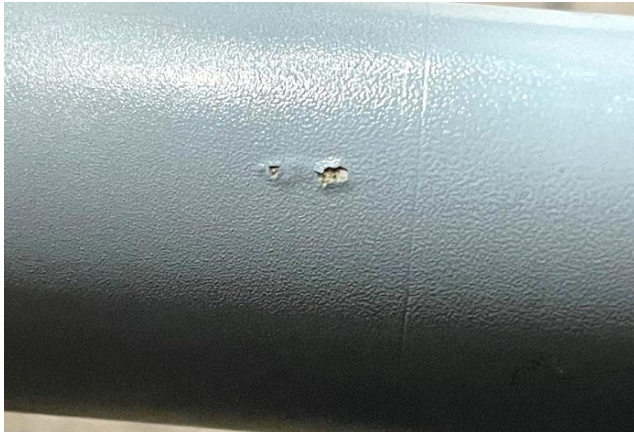
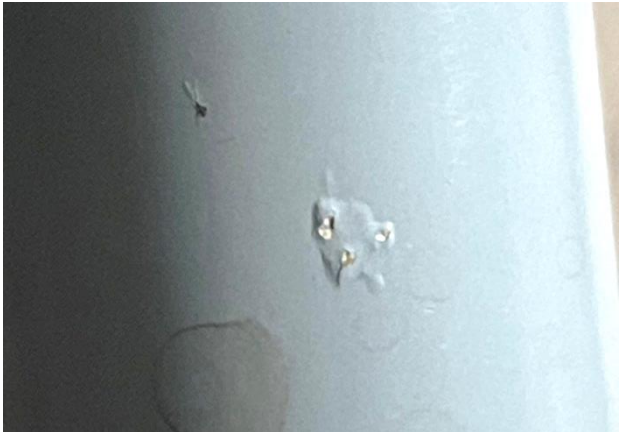
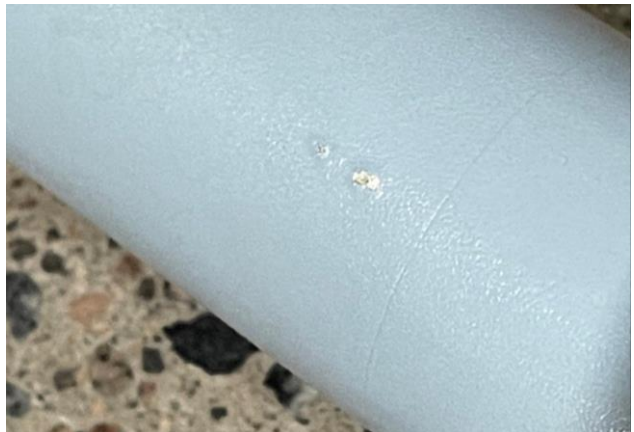
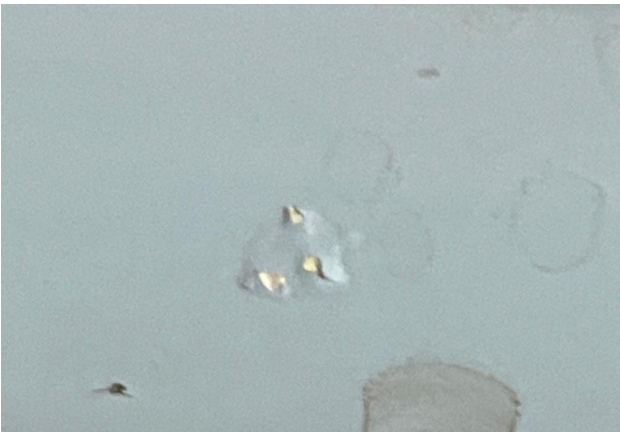
**Figure 202 – Examples of defects**

In case of detection of corrosion traces on the outer surface of XB-23 tail shaft 230-1526-000, as well as blistering (swelling) of the paint coating (see figure 202) – perform an additional inspection of the outer surface of the tail shaft for cracks and corrosion damages using IJM-15B method with the participation of the specialists of JSC “Reductor-PM”. Inspection results must be included in the Inspection report (Appendix 2).

1.4 In addition to the requirements stated in the task card 065.10.00a “Visual inspection of the transmission tail shaft” of the helicopter Maintenance manual, limitation shall be introduced in order to prevent the presence of corrosion traces, as well as blisters (swelling) of the paint coating (see Figure 202) on the outer surface of the XB-23 tail shaft.

1.2 XB-23 tail shafts 230-1526-000 with the defects detected during inspections using IJM-15B method must be removed from operation and sent for repair.

In case of detection of defects, perform an additional inspection of the tail shaft outer surface for cracks and corrosion damages using ЦМ-15В method with the participation of specialists of JSC “Reductor-PM” (inspection results must be included in the Inspection report according to the Appendix No. 2), in case of detection of defects – tail shaft must be removed from operation and sent for repair.
